**Docket No. 217 – Development and Management Plan Inspection**

Northeast Utilities Service Company Certificate of Environmental Compatibility and Public Need for the construction of a 345-kV electric transmission line and reconstruction of an existing 115-kV electric transmission line between Connecticut Light and Power Company's Plumtree Substation in Bethel, through the towns of Redding, Weston, and Wilton, and to the Norwalk Substation in Norwalk, Connecticut.

**Date:** March 15, 2006

**Location:** Transition Stations: Hoyts Hill, Archers Lane, Norwalk Junction

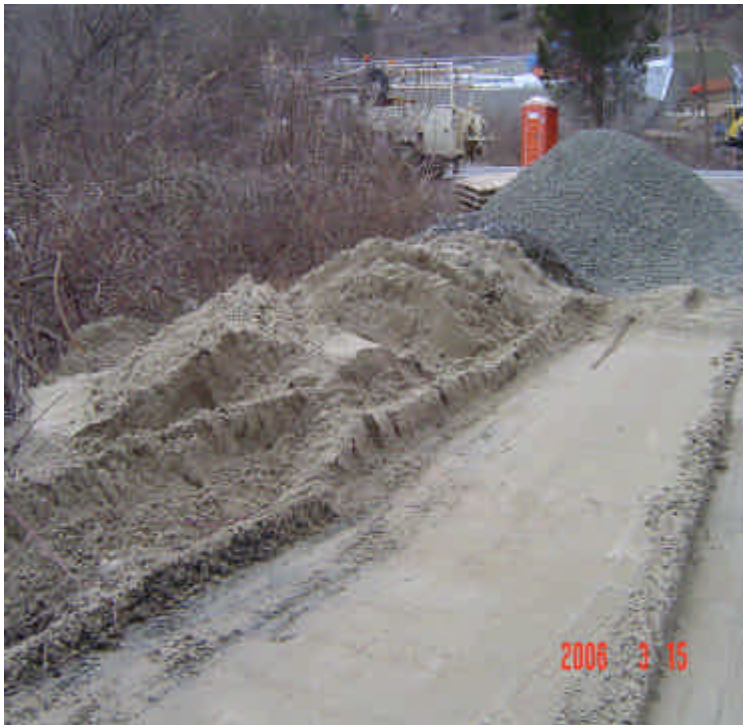
**Hoyts Hill Transition Station: Photo on the left shows a stockpile remaining across Rt 58 on the driveway. Controls are still needed here to contain it. Photo on the right shows an overview of the station pad where caissons are completed. 3/15/06**

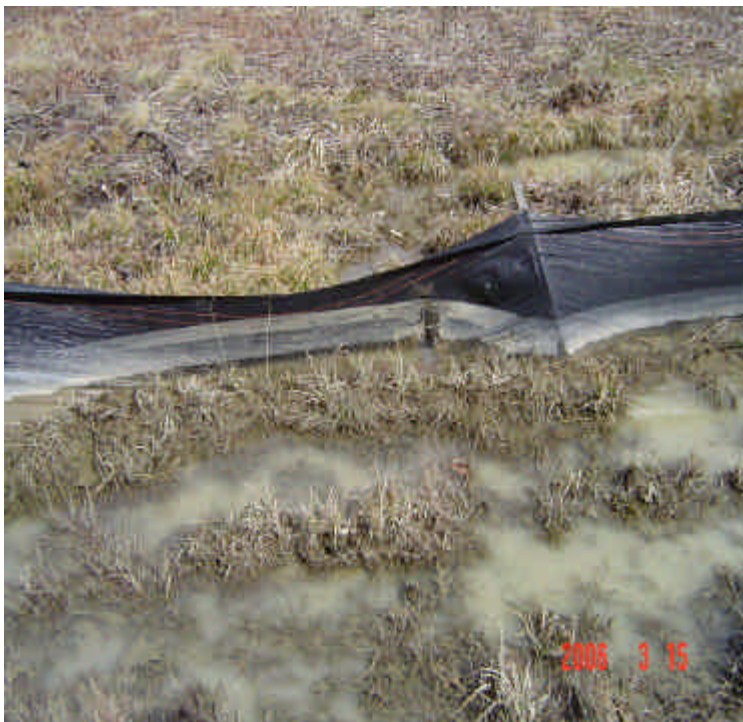
Erosion and Sediment Controls	<p>-<b>Hoyts Hill</b>: The perimeter silt fence along the wetlands at the rear of the station is still toed in but portions needs to be re-stapled and patched. 3/9/06 -Visible holes are allowing turbid water through. 3/15/06.</p> <p>- Sedimentation remains built up at the fence and in the wetland although contractors had made efforts to remove some of</p>	<p>-Some sections of fence will need to be replaced or well patched. 3/15/06. -It is unclear whether the turbid water is resulting from station dewatering or in combination with 345kV XLPE work.</p> <p>- Contractors will need to continue to remove sediment. 3/9-3/15/06. -There may be discussion as to whose responsibility</p>	<p>-Some efforts have been made to remove the sediment. Continue to do so. 3/9-3/15/06</p>

**Photo on the left shows a view of some turbid water that may be left over from either station or 345kV XLPE dewatering. Water was escaping through a hole in the fence without being filtered but Blakeslee will be patching this spot. Photo on the right shows where sediment from gullies has deposited at the base of slope. 3/15/06.**

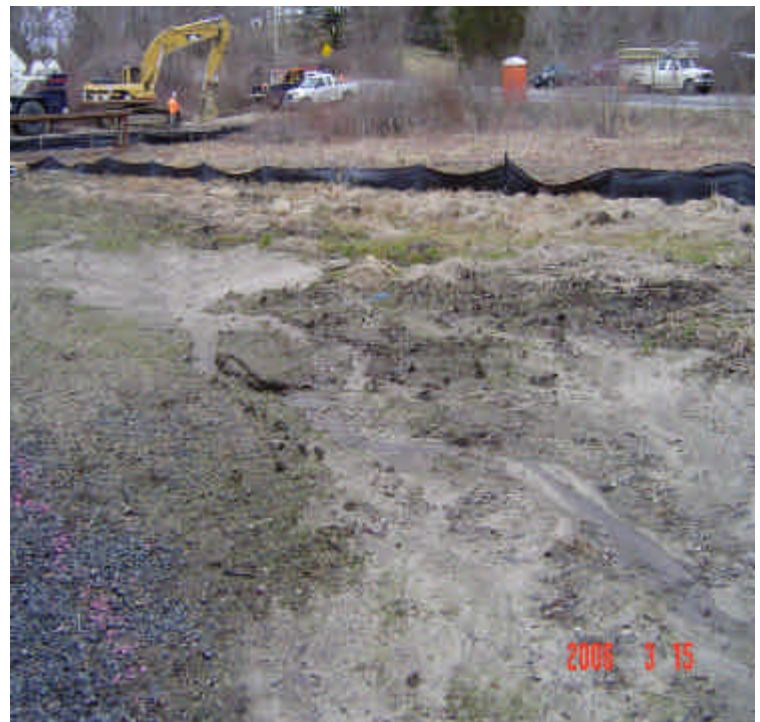
Areas of Inspection	Observation	Recommended Action	Corrected Actions
	the sediment. 3/9-3/15/06	this is as two different	
Erosion and Sediment Controls	<ul style="list-style-type: none"> <li>- The erosive gullies remain on both the northern and southern slopes . 10/27-3/15/06.</li> <li>-Less severe erosion was noted along the face of the southern silt fence. 1/26-3/15/06.</li> <li>- Dewatering is mostly complete from the pad but some turbid water resulted from recent discharges. 3/15/06.</li> <li>- A sand pile for mixing concrete was being stored in the driveway across from Rt. 58. 2/16-3/15/06.</li> </ul>	<p>contractors were dewatering. 3/15/06</p> <ul style="list-style-type: none"> <li>-Extension of the outlet stone pad and restoration of erosion will likely occur in the spring when access is stable. 3/2-3/15/06.</li> <li>-If dewatering needs to continue, a filter bag should be used to limit the turbidity before it enters the catch basin to the outlet. 3/15/06</li> <li>- Silt fence still needs to be installed at the stockpile since it is adjacent to wetlands. 2/16-3/15/06</li> </ul>	-Will be corrected in the spring. 3/15/06.

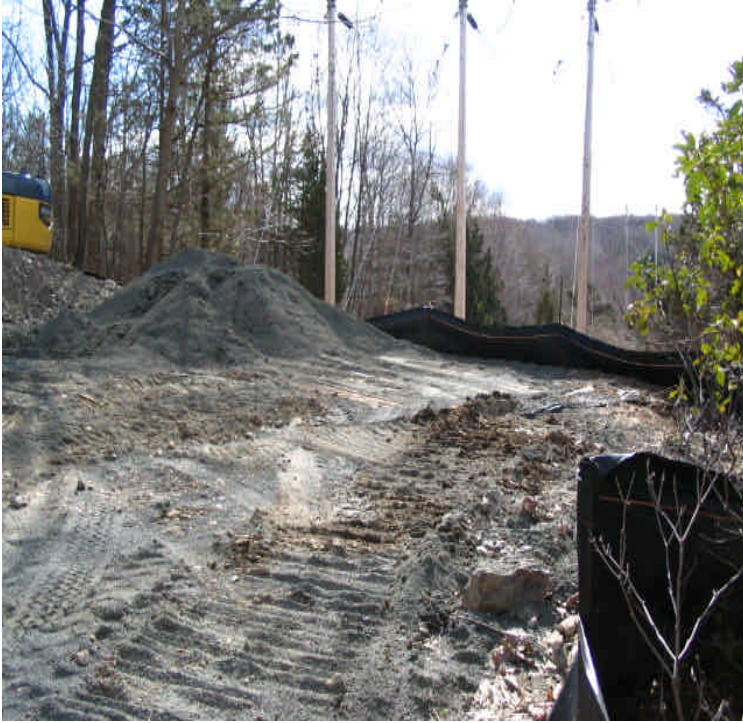
**Archers Lane Transition Station:** Photo on the left shows erosion controls installed around a stockpile as part of the 345kV work. Photo on the right shows a view of the station pad where trenching activities continue as part of the 345kV work. 3/15/06.

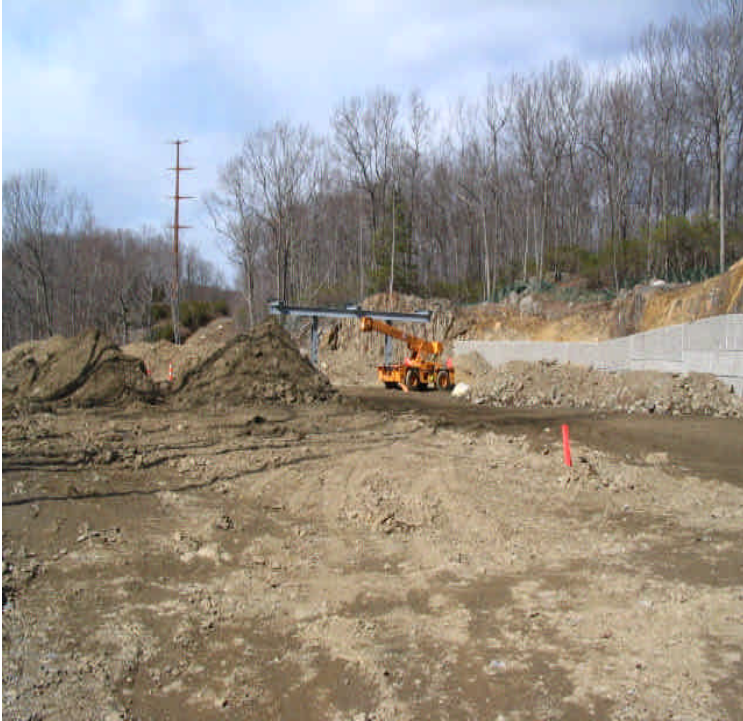
**Archers Lane:** Photo on the left shows an overall view of earth work and stockpile areas. **Norwalk Junction:** Photo on the right shows the excavations ongoing within the yard. All stockpiles and disturbed soil remain contained within the perimeter of the station pad for the most part. 3/15/06

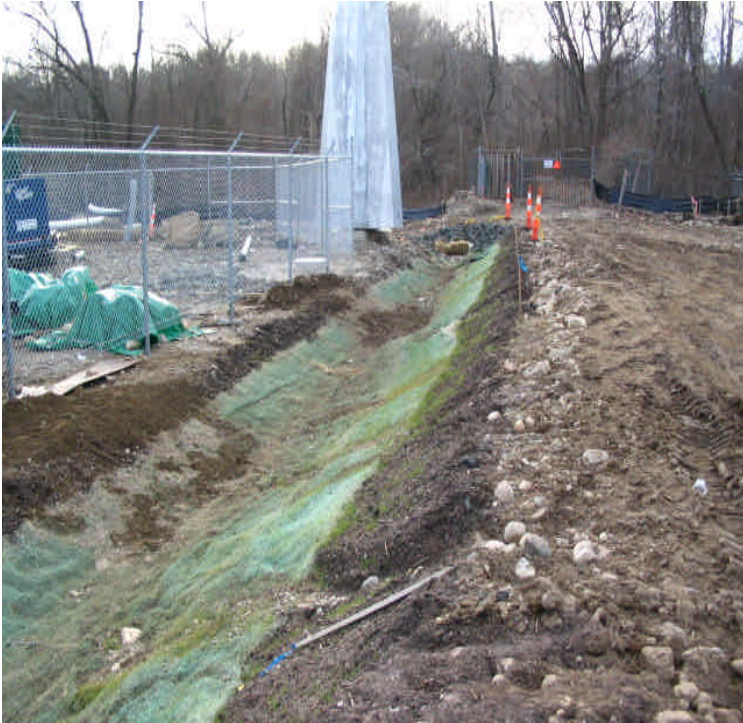
**Norwalk Junction:** Photo on the left shows additional sediment deposits in the lower drainage swale due to erosive gullies and remnants from previously plowed snow piles. The photo on the right shows sediment in the outlet pipe downgradient from the swale. This pipe discharges directly to the wetland. 3/15/06

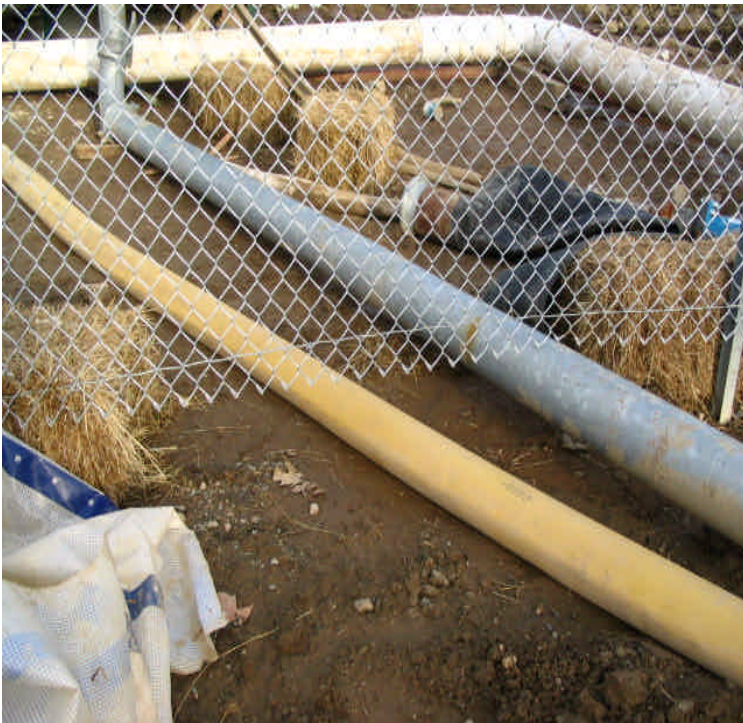
Photo on the left shows a break in the interior line of erosion controls where haybales were removed to place hoses. Photo on the right shows structures stored for installation and a view of the perimeter silt fence that remains intact. 3/15/06.

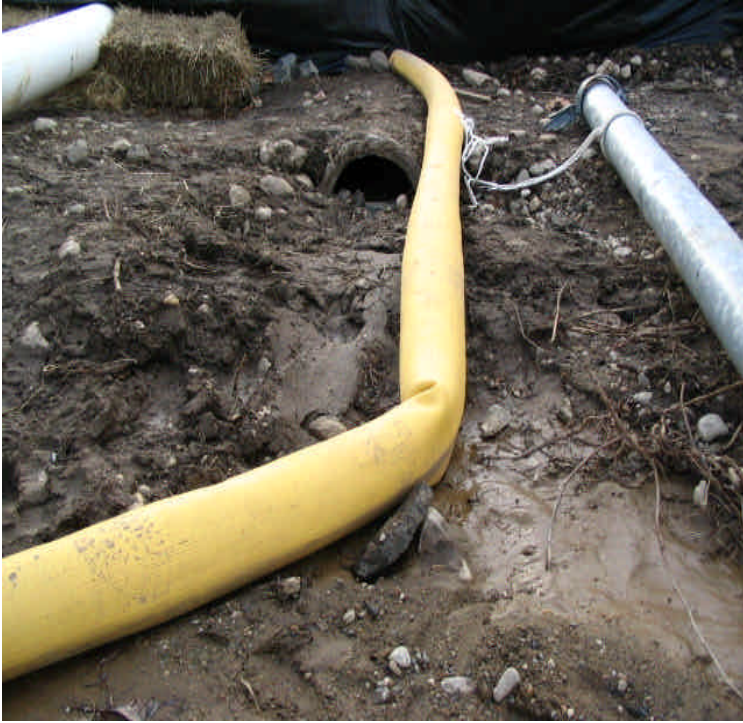
Areas of Inspection	Observation	Recommended Action	Corrected Actions
Erosion and Sediment Controls continued	<p>-The old culvert near the silt fence and the river was observed. It still shows evidence of occasional flow, including sediment from the disturbed soil at the site. 3/15/06</p> <p>-The wetland area outside the silt fence adjacent to the river shows accumulated sediment 3/8-3/15/06.</p> <p>- Sediment from previously plowed snow piles remained directly in and along the swale. This introduces more potential for turbidity. 2/16-3/15/06.</p> <p>- Erosive gullies remain in a number of locations along the lower drainage swale due to site run-off, resulting in further sedimentation to the swale. 12/30-3/15/06. Haybales remained in the inlets. 2/2-3/15/06.</p> <p>-The riprap swale remains to the Norwalk River for dewatering from the well points. 2/23-3/15/06.</p>	<p>- The culvert needs to have haybales installed if it is going to remain in place. Otherwise it should be removed/or the connection cut, completely 3/15/06</p> <p>- This area receives direct runoff from the site through the swale making water quality important. The adjacent site is disturbed resulting in this turbidity. 1/19-3/15/06.</p> <p>- Snow has melted but sediment could be removed from the swale. 3/8-3/15/06.</p> <p>- The erosion control matting on the swale likely needs to be extended up and over the top of slope to prevent further erosion until the growing season. 12/30-3/15/06.</p> <p>- Water from the pipe remains very clear.</p> <p>- Be sure to restore this outlet area when work is complete. 2/16-3/15/06.</p>	-N/A until work is complete.

Photo on the left shows the remaining portion of the old stone culvert filled with sediment and not protected with erosion controls. Photo on the right shows evidence that this portion of culvert is still discharging and depositing sediment into the wetland. 3/15/06

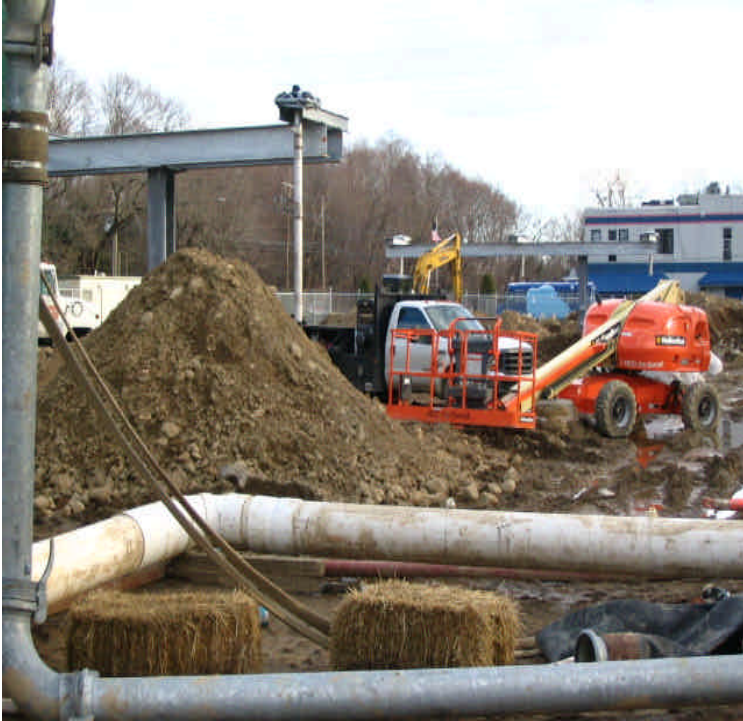
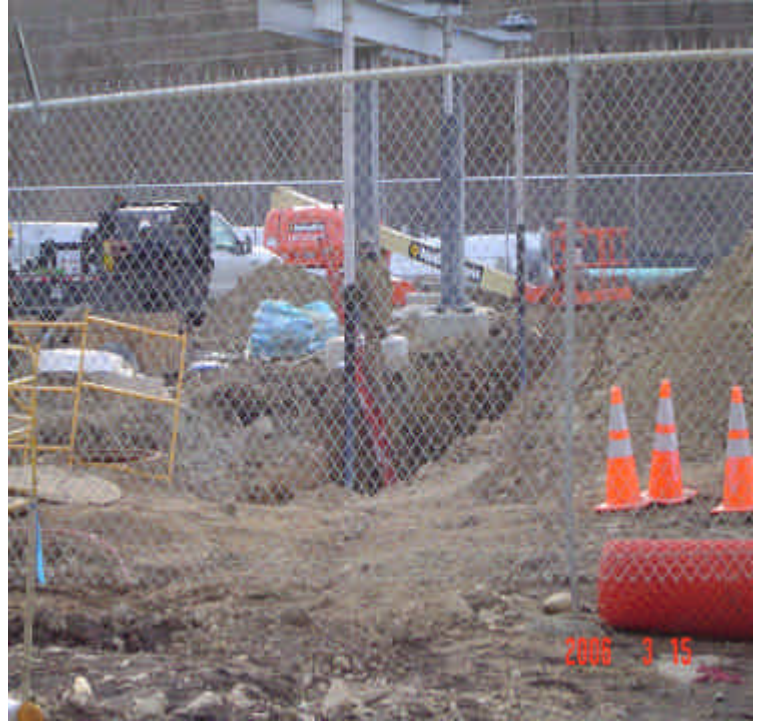
Both photos show the overall work on the station pad. Excavation continues and stockpiles remain fairly well contained. 3/15/06
